UNDERWATER INSPECTION REPORT
FOR
THE HOMER HADLEY FLOATING BRIDGE
BRIDGE NO. 90/25N

SEPTEMBER 2006

WASHINGTON STATE DEPARTMENT OF TRANSPORTATION

Prepared By:
Daniel G. Stromberg, P.E.
COLLINS ENGINEERS, INC.
123 North Wacker Drive, Suite 300
Chicago, Illinois 60606
312.704.9300

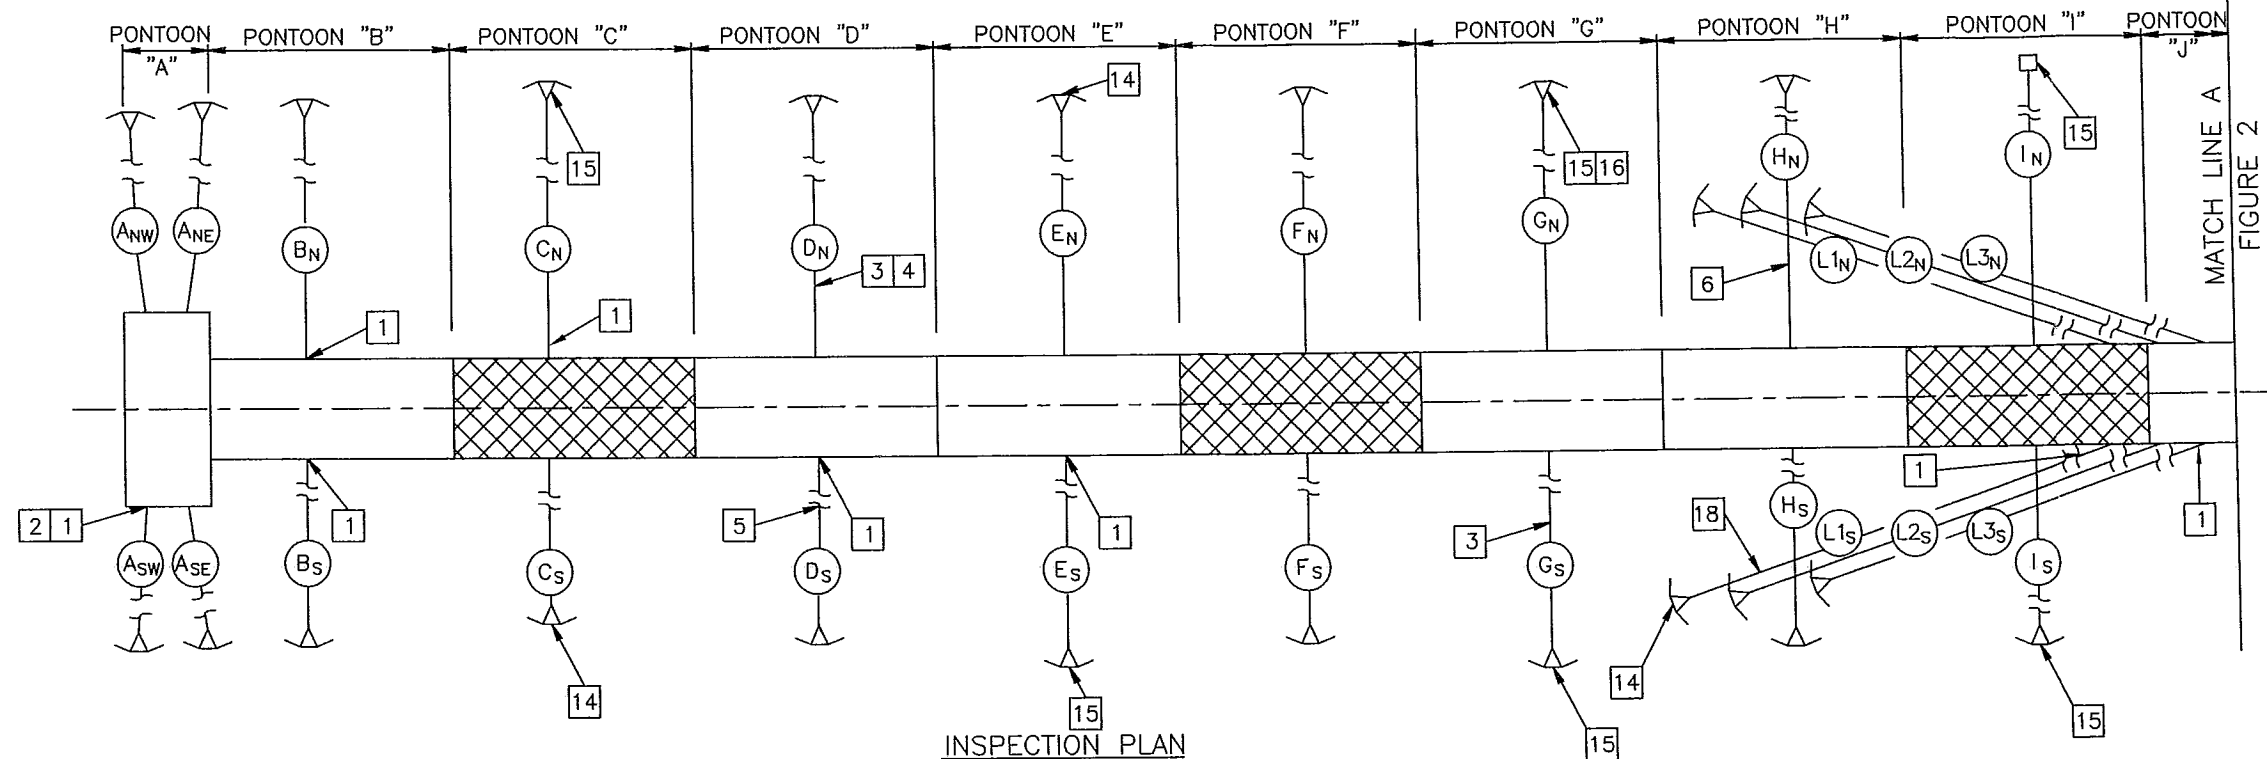
INSPECTION PLAN

- PONTOONS C, F, I, L, O, AND R WERE FULLY INSPECTED. THE UNDERWATER SURFACES OF THE PONTOONS WERE TYPICALLY COVERED WITH A THIN LAYER OF ALGAE GROWTH. CLEANING OF THE GROWTH REVEALED THE CONCRETE TO BE IN GOOD CONDITION WITH NO SIGNIFICANT STRUCTURAL DEFICIENCIES.

- ALL CABLES WERE INSPECTED BY DIVING TO A WATER DEPTH OF 50 FEET, EXCEPT FOR CABLES BN THROUGH QN, WHICH WERE INSPECTED TO THE BOATER PROTECTION SYSTEM CLAMP. IN ADDITION, CABLES CN, CS, EN, ES, GN, GS, IN, IS, KN, KS, L1S, L4S, L5S, L6S, LN, MN, MS, NN, ON, OS, QN AND QS WERE INSPECTED ENTIRELY FROM THE PONTOON PORT TO THE ANCHOR (OR LAKEBED IF ANCHOR WAS BURIED) BY DIVING OR WITH A ROV.

- THE BOATER PROTECTION SYSTEM WAS IN GENERALLY SATISFACTORY CONDITION WITH A MAJORITY OF THE CLEVIS PINS, AT THE CABLE CLAMP, EXHIBITING UP TO 50% LOSS OF SECTION DUE TO WEAR.

- HEAVY CORROSION, WITH UP TO 1/16" PITTING AND EXTERIOR WIRE SECTION LOSS, COVERING 50% TO 100% OF THE CABLE SURFACE. AFFECTED AREA EXTENDED FROM WITHIN THE PONTOON PORT UP TO WATER DEPTHS OF 17 FEET.

- PROTECTIVE SLEEVE WITHIN THE PONTOON PORT IS OPEN, EXPOSING 6 TO 8 BROKEN CABLE WIRES. SEIZING REPAIRS WERE NOT PERFORMED DUE TO INACCESSABILITY.
- ONE OR MORE WIRES OUT-OF-LAY UP TO ONE WIRE DIAMETER.

- MODERATE ABRASION OF PHILLYSTRAN ARAMID FIBER BUOY ROPE.
- CORROSION NODULES UNDER PREVIOUS SEIZING REPAIR CAUSING INTERMITTENT BULGING OF WIRES UP TO 1/2 WIRE DIAMETERS.

- ONE BROKEN CABLE WIRE AT A WATER DEPTH OF 48 FEET. WIRE WAS SEIZED WITH CABLE TIES DURING INSPECTION.
- MISSING BUOY CLAMP CLEVIS PIN. ASSISTED WSDOT PERSONNEL WITH PIN REPLACEMENT.

- ONE LOOSE WIRE BULGING OUT UP TO ONE WIRE DIAMETER.
- FAILED REPAIRS OF TWO BROKEN CABLE WIRES AT A WATER DEPTH OF 8 FEET. WIRES WERE RE-SEIZED WITH CABLE TIES DURING INSPECTION.

- MISSING BOATER PROTECTION BUOY AND BUOY CLEVIS PIN. ASSISTED WSDOT PERSONNEL WITH BUOY AND PIN REPLACEMENT.
- SOUTH FACE OF FLUKE ANCHOR EXPOSED. VERTICAL EXPOSURE RANGED BETWEEN 3 FEET (ENDS) AND 8 FEET (CENTER).

- PROTECTIVE SLEEVE WITHIN THE PONTOON PORT IS OPEN APPROXIMATELY 4", EXPOSING TOP SURFACE OF CABLE.
- RANDOM AREA OF SECTION LOSS PRESENT ALONG LENGTH OF VERTICAL JOINT

- FULL LENGTH INSPECTIONS REVEALED THE CABLE AND/OR EYEBAR, TO BE PENETRATING THE LAKEBED WITH NO PORTION OF THE ANCHOR EXPOSED.
- FULL LENGTH INSPECTIONS REVEALED THE CABLE, SOCKET, PINS, EYEBAR, ANCHOR CONNECTIONS, AND/OR ANCHOR TO BE PARTIALLY OR FULLY EXPOSED.

- TOP OF FLUKE ANCHOR EXPOSED. VERTICAL EXPOSURE WAS BETWEEN 6 INCHES AND 2 FEET.
- NORTH FACE OF FLUKE ANCHOR EXPOSED. VERTICAL EXPOSURE RANGED BETWEEN 3 AND 4 FEET.

- TWO INACTIVE ANCHOR CABLES OF ABANDONED PONTOONS, RESTING AGAINST CABLE SURFACE AT WATER DEPTHS BETWEEN 160 AND 161 FEET

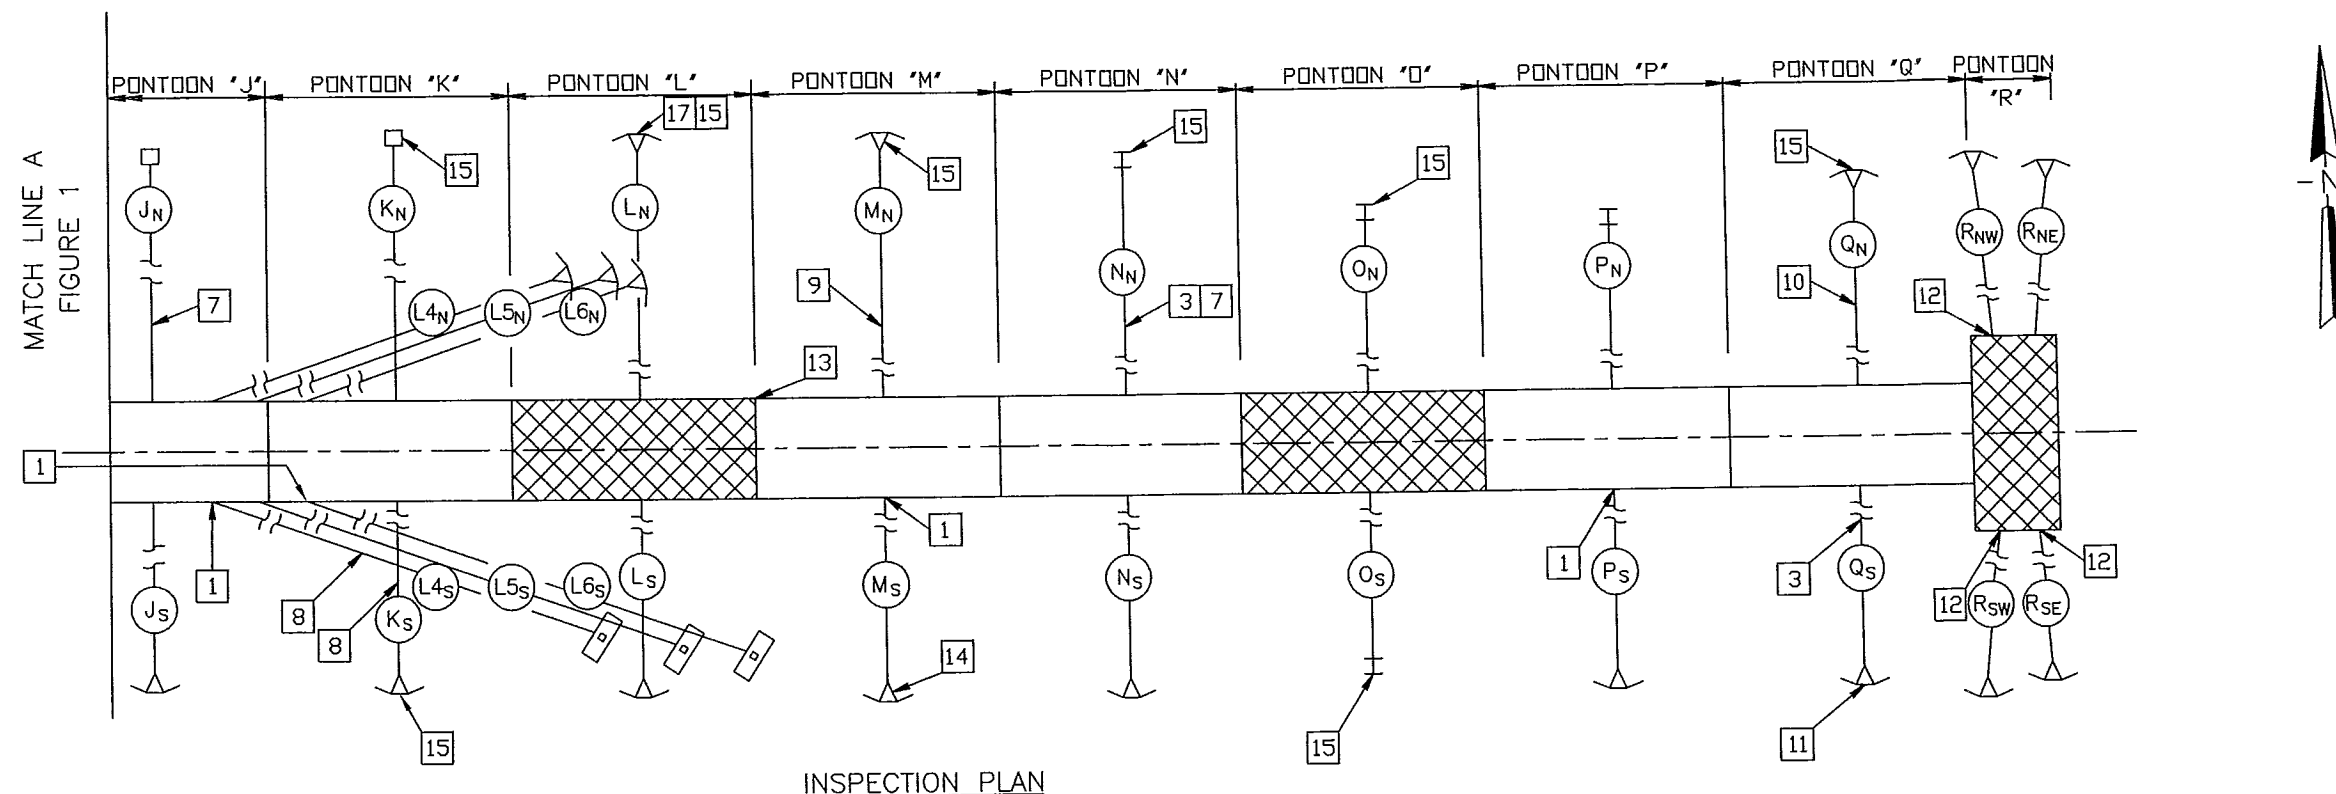
INSPECTION PLAN

- PONTOONS C, F, I, L, O, AND R WERE FULLY INSPECTED. THE UNDERWATER SURFACES OF THE PONTOONS WERE TYPICALLY COVERED WITH A THIN LAYER OF ALGAE GROWTH. CLEANING OF THE GROWTH REVEALED THE CONCRETE TO BE IN GOOD CONDITION WITH NO SIGNIFICANT STRUCTURAL DEFICIENCIES.

- ALL CABLES WERE INSPECTED BY DIVING TO A WATER DEPTH OF 50 FEET, EXCEPT FOR CABLES Bn THROUGH Qn, WHICH WERE INSPECTED TO THE BOATER PROTECTION SYSTEM CLAMP. IN ADDITION, CABLES Cn, Cs, En, Es, Gn, Gs, In, Is, Kn, Ks, L1s, L4s, L5s, L6s, Ln, Mn, Ms, Nn, On, Os, Qn AND Qs WERE INSPECTED ENTIRELY FROM THE PONTOON PORT TO THE ANCHOR (OR LAKEBED IF ANCHOR WAS BURIED) BY DIVING OR WITH AN ROV.

- THE BOATER PROTECTION SYSTEM WAS IN GENERALLY SATISFACTORY CONDITION WITH A MAJORITY OF THE CLEVIS PINS, AT THE CABLE CLAMPS EXHIBITING UP TO 50% LOSS OF SECTION DUE TO WEAR.

- HEAVY CORROSION, WITH UP TO 1/16" PITTING AND EXTERIOR WIRE SECTION LOSS, COVERING 50% TO 100% OF THE CABLE SURFACE. AFFECTED AREA EXTENDED FROM WITHIN THE PONTOON PORT UP TO WATER DEPTHS OF 17 FEET.

- PROTECTIVE SLEEVE WITHIN THE PONTOON PORT IS OPEN, EXPOSING 6 TO 8 BROKEN CABLE WIRES. SEIZING REPAIRS WERE NOT PERFORMED DUE TO INACCESSABILITY.
- ONE OR MORE WIRES OUT-OF-LAY UP TO ONE WIRE DIAMETER.

- MODERATE ABRASION OF PHILLYSTRAN ARAMID FIBER BUOY ROPE.
- CORROSION NODULES UNDER PREVIOUS SEIZING REPAIR CAUSING INTERMITTENT BULGING OF WIRES UP TO 1/2 WIRE DIAMETERS.

- ONE BROKEN CABLE WIRE AT A WATER DEPTH OF 48 FEET. WIRE WAS SEIZED WITH CABLE TIES DURING INSPECTION.
- MISSING BUOY CLAMP CLEVIS PIN. ASSISTED WSDOT PERSONNEL WITH PIN REPLACEMENT.

- ONE LOOSE WIRE BULGING OUT UP TO ONE WIRE DIAMETER.
- FAILED REPAIRS OF TWO BROKEN CABLE WIRES AT A WATER DEPTH OF 8 FEET. WIRES WERE RE-SEIZED WITH CABLE TIES DURING INSPECTION.

- MISSING BOATER PROTECTION BUOY AND BUOY CLEVIS PIN. ASSISTED WSDOT PERSONNEL WITH BUOY AND PIN REPLACEMENT.
- SOUTH FACE OF FLUKE ANCHOR EXPOSED. VERTICAL EXPOSURE RANGED BETWEEN 3 FEET (ENDS) AND 8 FEET (CENTER).

- PROTECTIVE SLEEVE WITHIN THE PONTOON PORT IS OPEN APPROXIMATELY 4", EXPOSING TOP SURFACE OF CABLE.
- RANDOM AREA OF SECTION LOSS PRESENT ALONG LENGTH OF VERTICAL JOINT
- FULL LENGTH INSPECTIONS REVEALED THE CABLE AND/OR EYEBAR, TO BE PENETRATING THE LAKEBED WITH NO PORTION OF THE ANCHOR EXPOSED.
- FULL LENGTH INSPECTIONS REVEALED THE CABLE, SOCKET, PINS, EYEBAR, ANCHOR CONNECTIONS, AND/OR ANCHOR TO BE PARTIALLY OR FULLY EXPOSED.
- TOP OF FLUKE ANCHOR EXPOSED. VERTICAL EXPOSURE WAS BETWEEN 6 INCHES AND 2 FEET.
- NORTH FACE OF FLUKE ANCHOR EXPOSED. VERTICAL EXPOSURE RANGED BETWEEN 3 AND 4 FEET.
- TWO INACTIVE ANCHOR CABLES, OF ABANDONED PONTOON, RESTING AGAINST CABLE SURFACE AT WATER DEPTHS BETWEEN 160 AND 161 FEET.
